RESOLUTION NO. 2021- 553

**A RESOLUTION APPROVING THE ADVANCEMENT OF
A ROAD DIET AND OTHER SUBSTANTIVE SAFETY
IMPROVEMENTS ON CHESTNUT AVENUE BETWEEN
MAIN ROAD AND DELSEA DRIVE.**

#2018400106 | March 2020

Pedestrian and Bicycle Road Safety Audit Report

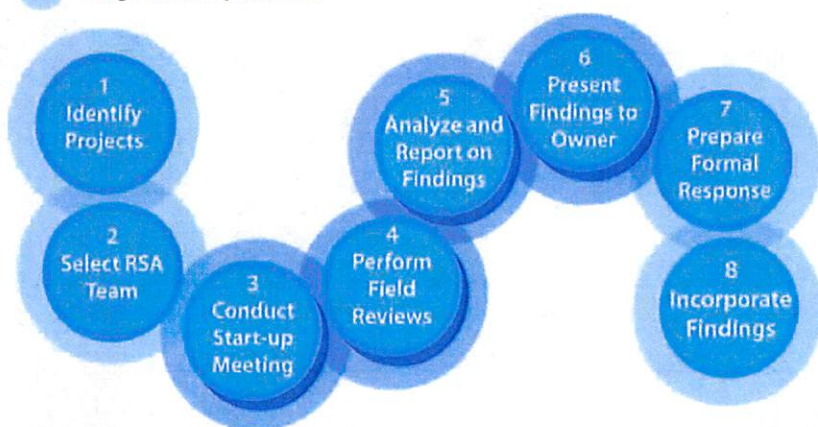
Eight-Step RSA Process (FHWA-SA-07-07)

The PRSA event has three basic components:

- **Pre-Audit:** Audit team analyzes and discusses study area crash data and related issues.
- **Field Visit:** The audit team walks the corridor to identify safety issues and examine conditions.
- **Post-Audit:** The audit team shares findings and develops a list of problems and potential strategies.

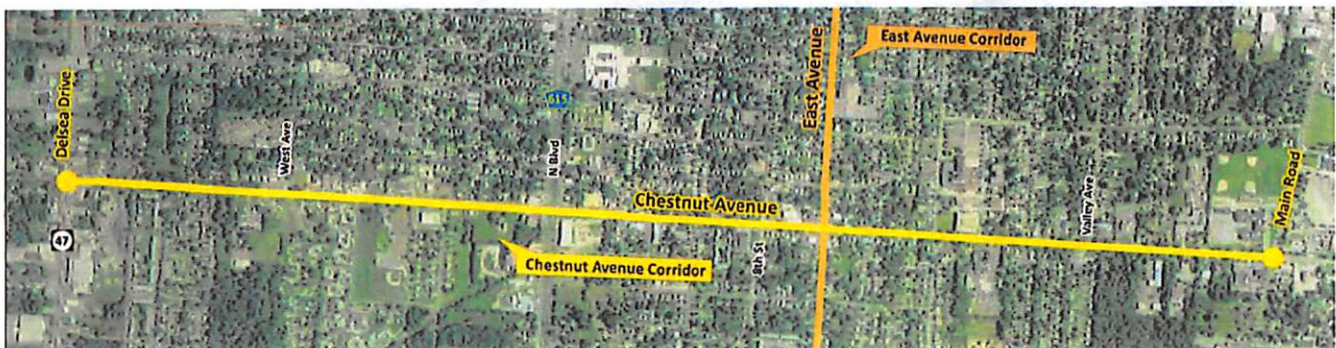
Figure 1: Chestnut Avenue Study Area

As shown in *Figure 1*, the focus of this audit is a 2.3-mile section of Chestnut Avenue located in the urban area of Vineland, New Jersey. Audit limits are between NJ 47 (Delsea Drive) and CR 555 (Main Road)(MP 0.00-2.30). This corridor is a local east-west connector that bisects north-south collectors CR 615 (South West/South East Boulevard), West Avenue, and East Avenue. The corridor is surrounded by a mix of commercial and low to medium-density residential development. It is important to note that the corridor includes a park, nursing home, EMS station, two schools, and public housing.

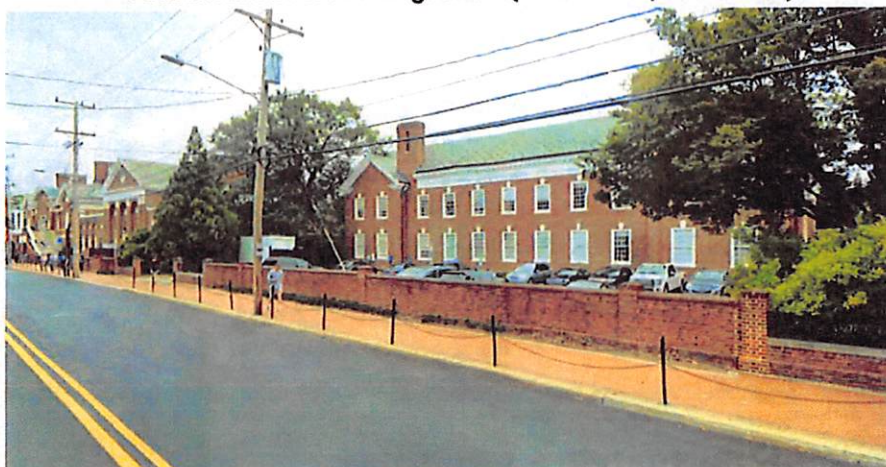
Photo Caption: (Google Earth) Newark, DE

Pedestrian Access Management (i.e. barriers, fences etc.)

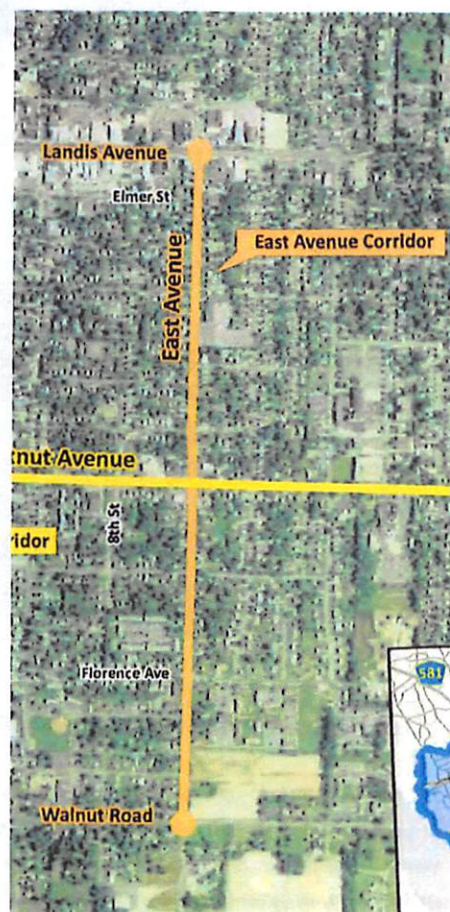
Figure 1: East Avenue Study Area

Sidewalk conditions vary from satisfactory to needing maintenance. Basic parallel style crosswalks are provided at signalized intersections. Crosswalk conditions vary from newly stripped to in-need of restriping. There are no bicycle lanes or other bicycle infrastructure identified along the corridor. However, the *2015 Cumberland County Bikeways Inventory* and *2010 Cumberland County Rails to Trails Feasibility Study* both propose East Avenue as a potential bikeway.

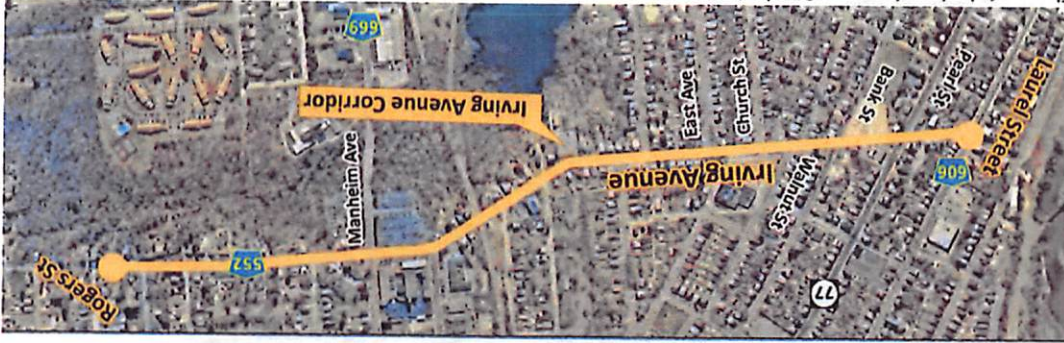
Figure 1: Irving Avenue Study Area

As shown in *Figure 1*, the focus of this audit is a 1-mile section of Irving Avenue located in the urban area of Bridgeton, New Jersey. Audit limits are between CR 606 (Laurel Street) and Rogers Street (MP 0.00-1.02). This corridor runs east to west and is a rural gateway into Bridgeton that bisects notable north-south roadways NJ 77 (Pearl Street) and CR 669 (Manheim Avenue). The corridor is surrounded by low-density residential and commercial development. It is important to note that the corridor includes a hospital and a children's medical clinic.

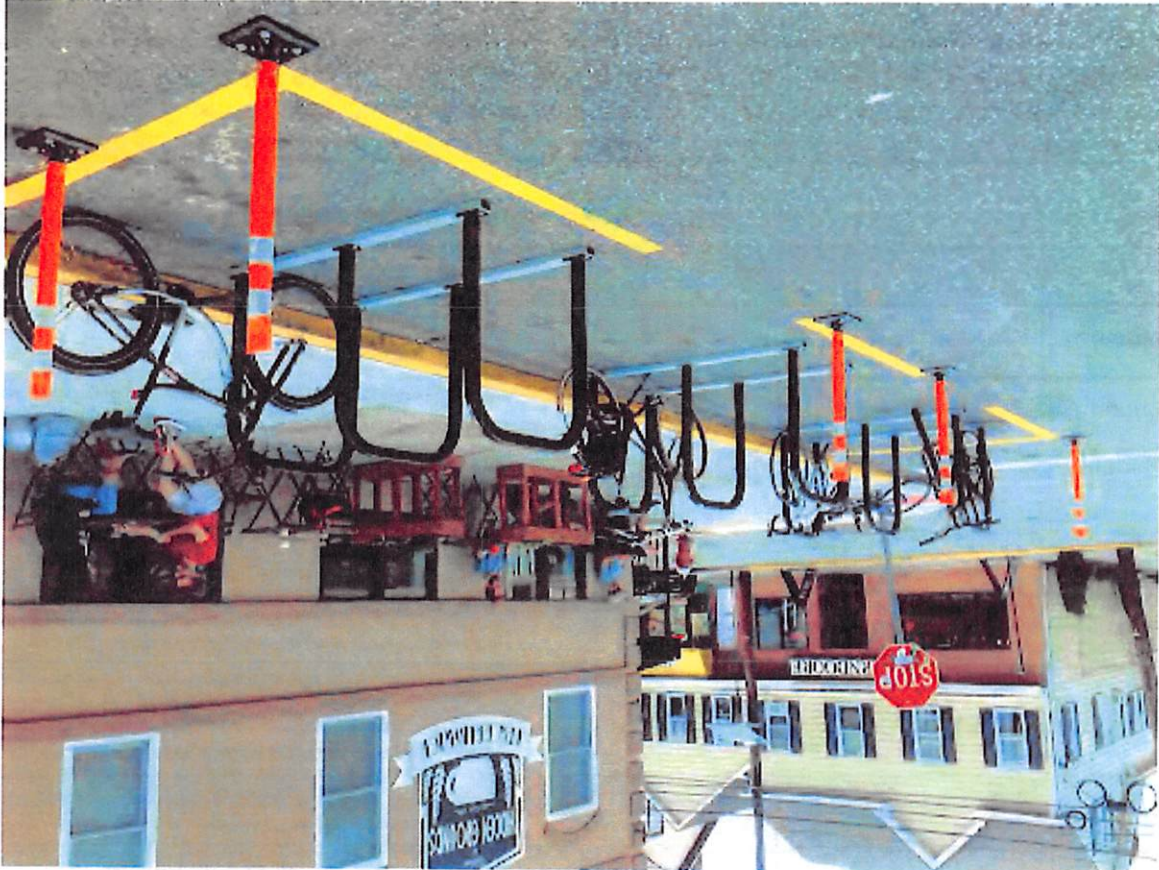
Daylighting Intersection (i.e. Bicycle parking, plastic bollards, stripings)

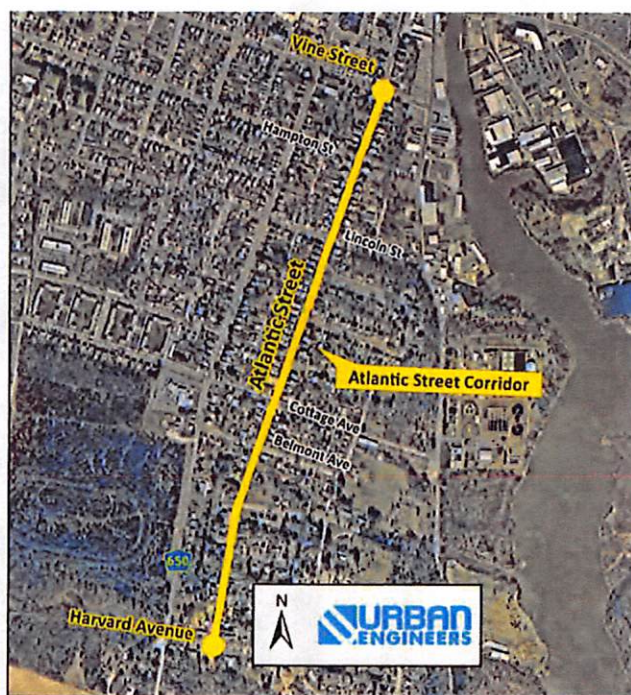
Figure 1: Atlantic Street Study Area

Based on data from the NJDOT Straight Line Diagrams (SLDs), the 2017 ADT along Atlantic Street is approximately 1,800 vehicles per day within the study area. A copy of available data can be found in Appendix B. Additional traffic counts of the study area will be conducted during upcoming project tasks. This data will be added to the PRSA report as a supplement to Appendix B and will be used to 1) complete a Highway Safety Manual (HSM) analysis of the study area, and 2) inform the evaluation of potential countermeasures.

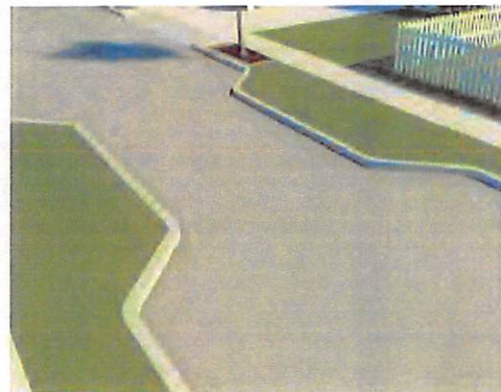
Speed cushions are speed humps or speed tables that include wheel cutouts that allow larger vehicles to pass unaffected but reduce passenger vehicle speeds. They are often used on key emergency response routes to allow emergency vehicles to pass unimpeded while causing the typical passenger vehicle to slow down. Speed cushions should be used with caution, however, as drivers will often seek out the space in between the humps.

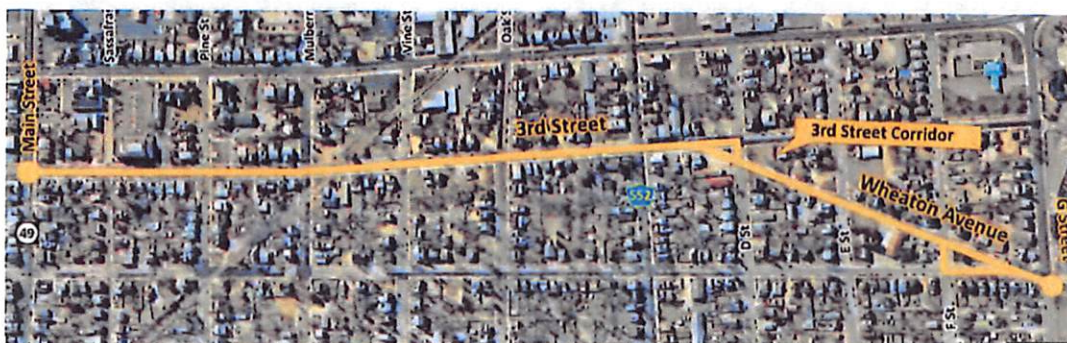
Figure 1: 3rd Street Study Area

As shown in *Figure 1*, the focus of this audit is a 1-mile section of CR 555 (3rd Street/Wheaton Avenue). At a point approximately 100 feet south of D Street (MP 10.58) the study area changes from 3rd Street to Wheaton Avenue. For the sake of clarity the study corridor will be referred to as 3rd Street. Located in the urban area of Millville, New Jersey. Audit limits are between NJ 49 (Main Street) and G Street (MP 10.05-10.83). This corridor runs north-south. The corridor is surrounded by low-density residential and some commercial development.

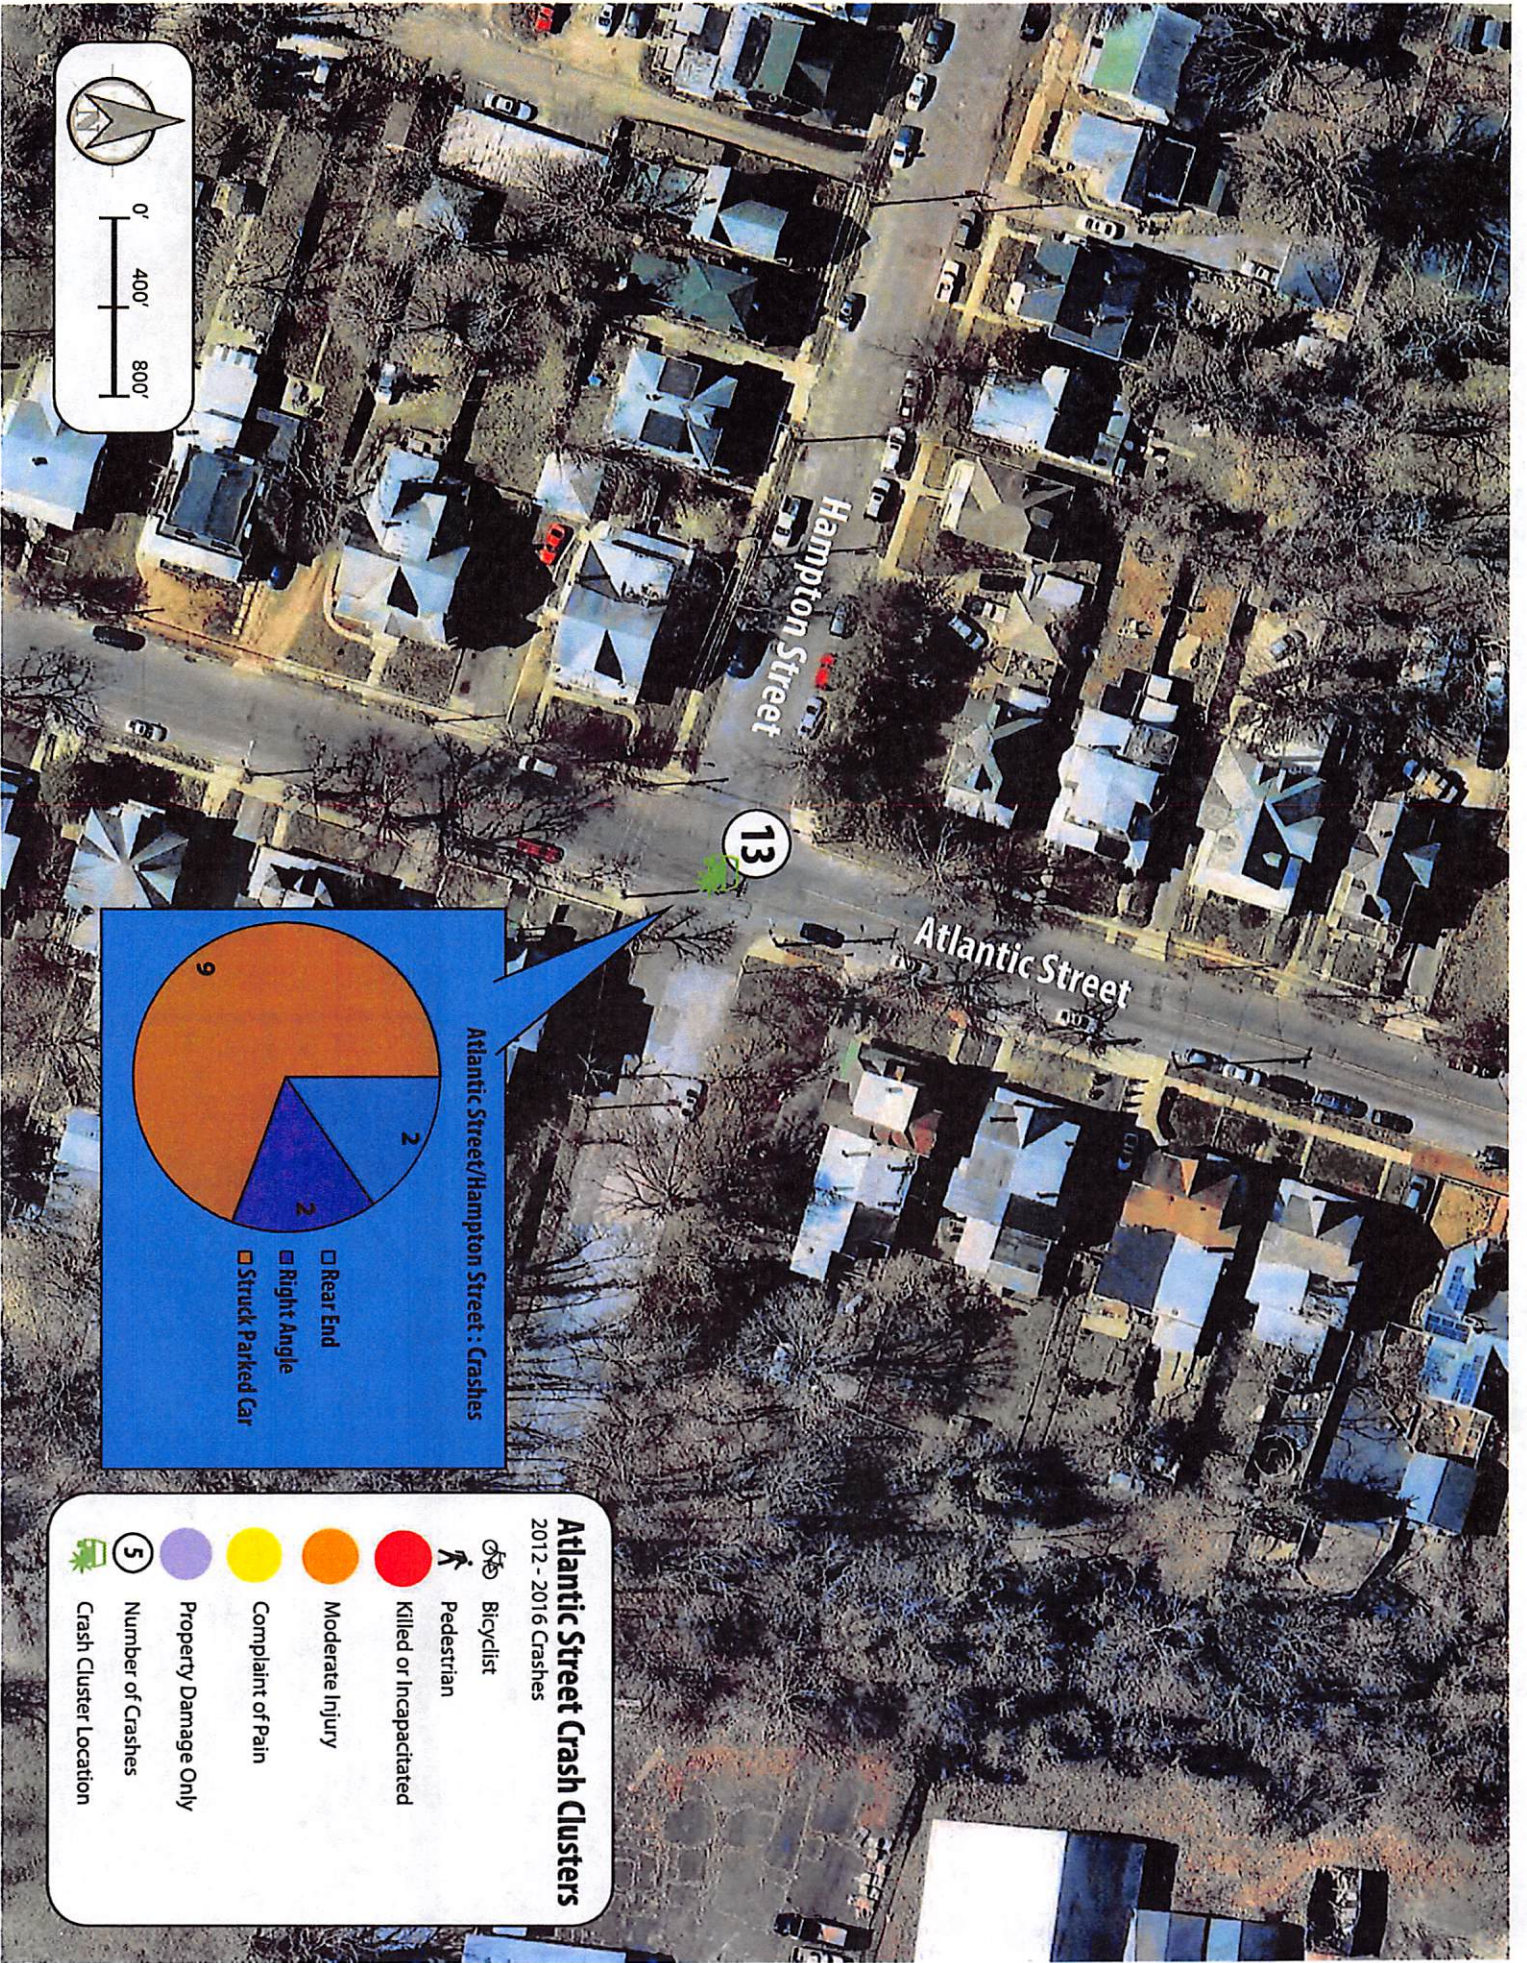
2012 - 2016 Crashes

- Bicyclist
- Pedestrian
- Killed or Incapacitated
- Moderate Injury
- Complaint of Pain
- Property Damage Only
- Number of Crashes
- Crash Cluster Location
